**A report on the incident that occurred on  
the Isle of Berneray, Outer Hebrides, on the  
4th of April 2020  
Mr Michael Orr -v- Mr Peter Anderson**

**A report prepared for the Court by G.R.Greatrix, Forensic Investigator**

**Report of: Graham R Greatrix  
Specialist field: Forensic Investigation  
Case: Mr Michael Orr -v- Mr Peter Anderson  
On behalf of: Marshalls, Solicitors, Preston. Ref: FI/10256**

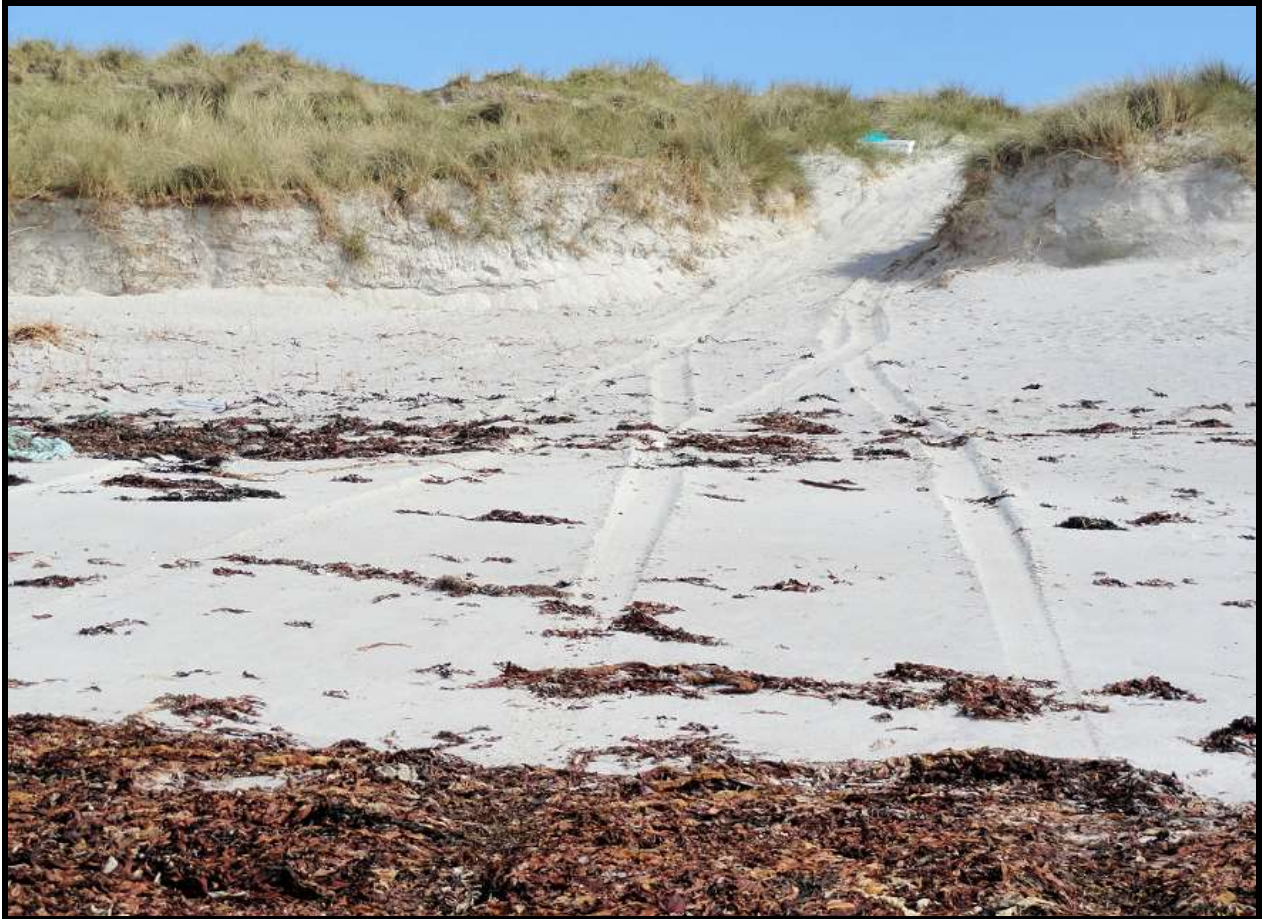
**Photograph 2: Tyre marks on the beach showing evidence of vehicles entering and leaving the beach via the track seen in Photograph 1.**

- 20 Photograph 2 shows evidence of vehicles entering and leaving the beach via the track through the dunes.
- 21 Photograph 3, upper, shows the front nearside tyre on the Land Rover Discovery. The tread pattern is unusual because there are no

- 37 Photographs 2 and 3 show tyre marks in the beach sand indicating that vehicles are able to enter and leave the beach via the track.
- 38 I suggest that Mr Anderson's claim that he could not leave the beach in his four-wheel drive Land Rover Discovery without assistance is invalid.

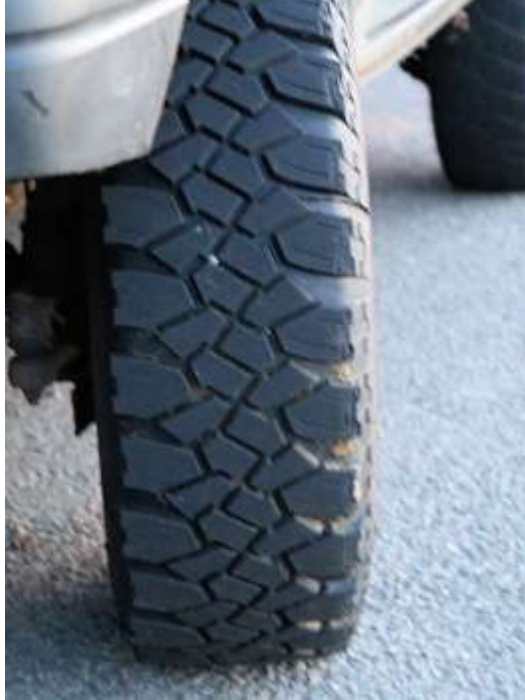
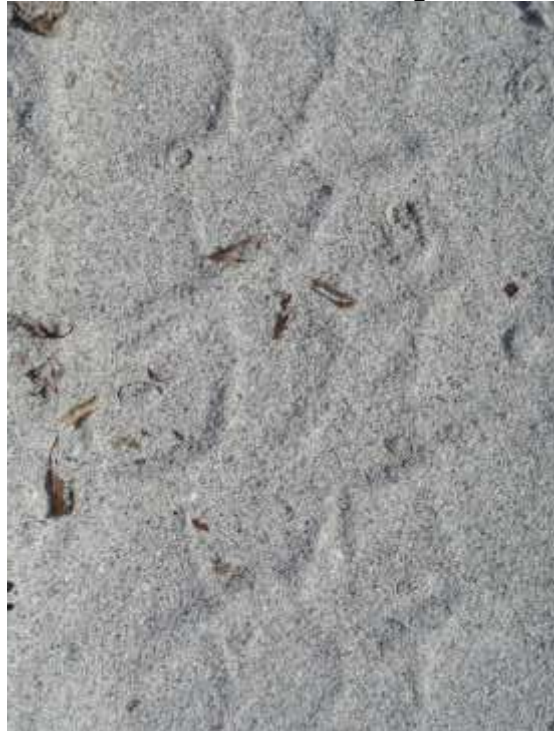
### Photograph 3

This was taken on the 2nd of June 2017 using a Canon EOS 60D camera.

Photo taken on the 6th of May 2017 at 3.02 pm using a DSC-H70 Sony Cyber-shot camera. About three hours after the incident.

circumferential grooves in the pattern. The tyre is designed as an off-road tyre.

- 22 Photograph 3, lower, shows a tyre impression in the sand. The photograph was taken on the 6th of May 2017 at 3.02 pm using a DSC-H70 Sony Cyber-shot camera. The time is about three hours after the incident.

- 23 The impresssion in the sand clearly shows the characteristics of the tyre tread in Photograph 3, upper.
- 24 In photograph 4 I have shown the tyre impression in the sand along with the metadata embedded in the photograph.

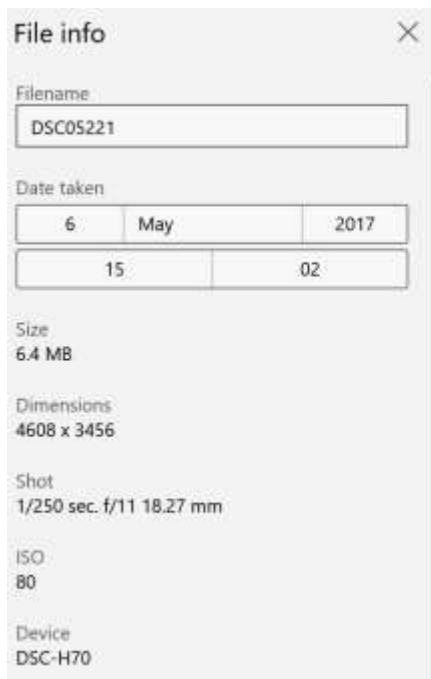
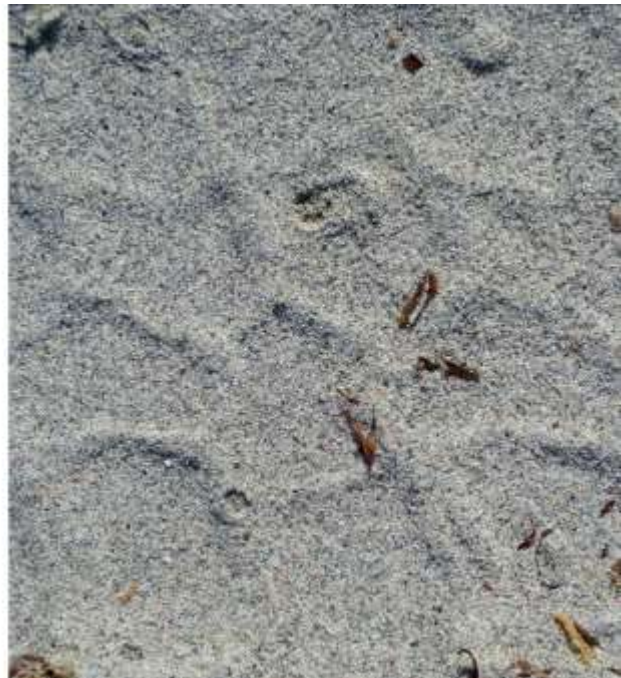
Photograph 4 showing the metadata.

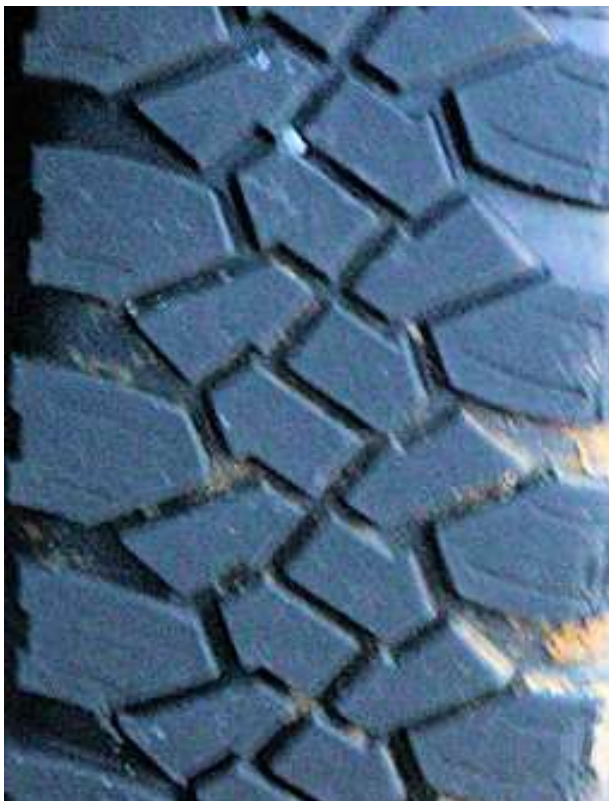
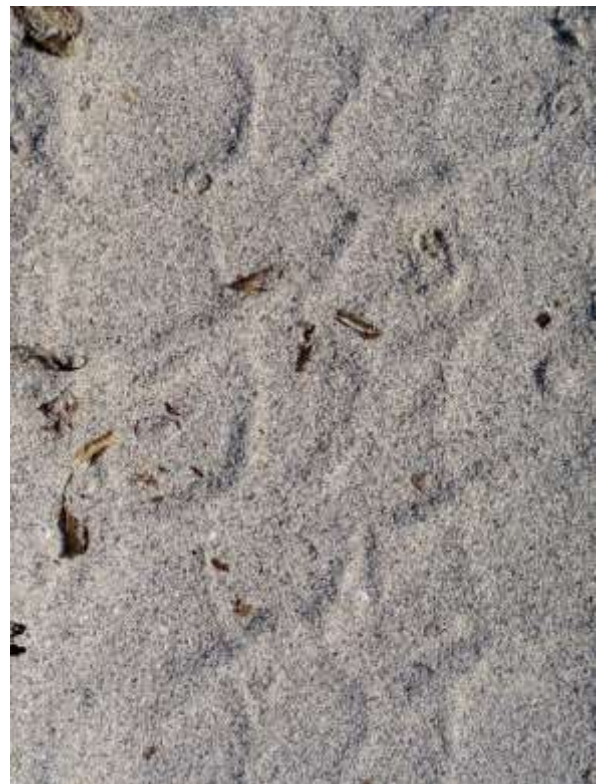
Photograph 5: Tyre and tyre print in the sand.

- 25 Photograph 5 shows an extract from image of the Land Rover tyre placed above an extract from the impressioun in the sand. The similarity of the tread pattern on the tyre and the impression of the tread pattern in the sand is clear.

- 26 I suggest that the evidence shown in Photographs 3, 4 and 5 shows that Mr Anderson's Land Rover was on the beach on the day of the incident with a high probability that it was present at the alleged time of the incident.

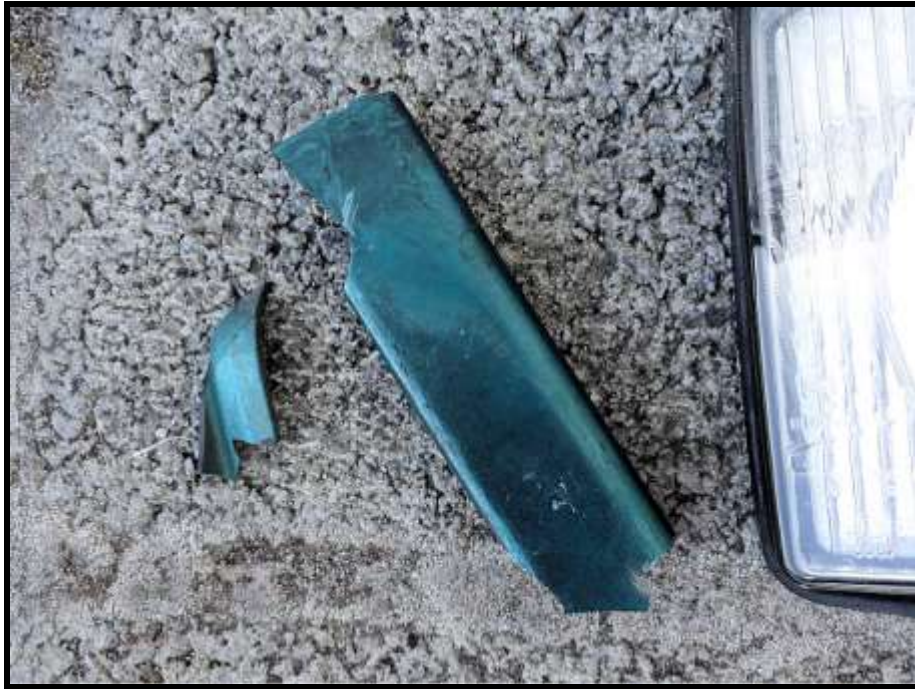
**Photograph 6 shows the pieces of a Land Rover Discovery that were found embedded in the bike.**

- 39 After the incident, Mr Orr found a Land Rover Discovery headlight and some plastic embedded in his bike. Photograph 4 shows those found items.
- 40 Photograph 10 shows that, eleven days post-incident, the Land Rover had a replacement nearside headlight.

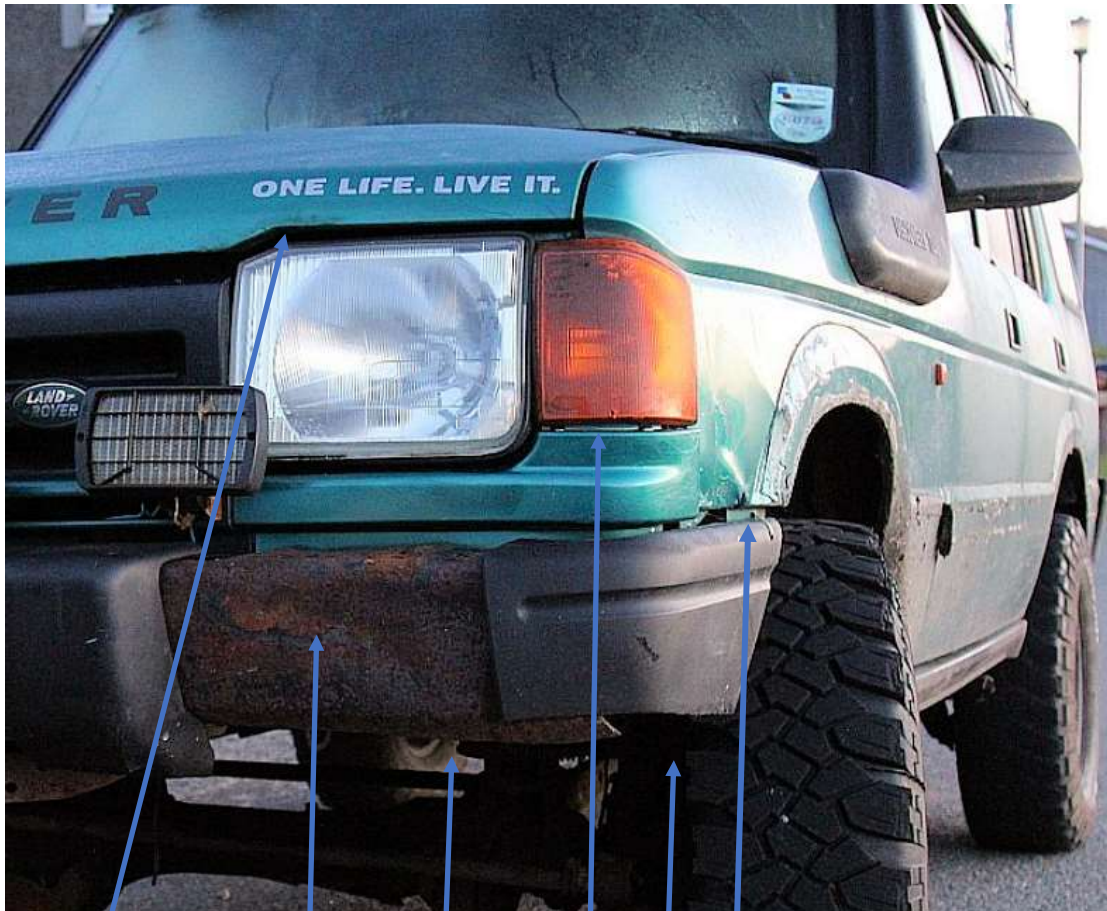
### Defendant's vehicle Photograph 7

Bonnet damage

missing section  
including washer

Gap

missing or broken off  
lower bumper parts

- 27 Photograph 6 shows an undamaged Land Rover Discovery.
- 28 Photograph 7 shows the front offside of the Land Rover shortly after it re-appeared.

- 29 I have placed arrows on the photograph to highlight the damage present and where other items are missing. The gaps are excessively large.
- 30 Photograph 8 shows the front of Mr Orr's quadbike. I have also placed arrows on this photograph highlighting what damage can be seen. However, there is also damage within the bike that cannot be seen.

- 41 For reference, I have shown a photograph of an undamaged Land Rover Discovery at Photograph 6.
- 42 Photograph 7 shows evidence of collision damage on the Land Rover after Mr Anderson had carried out some repairs.

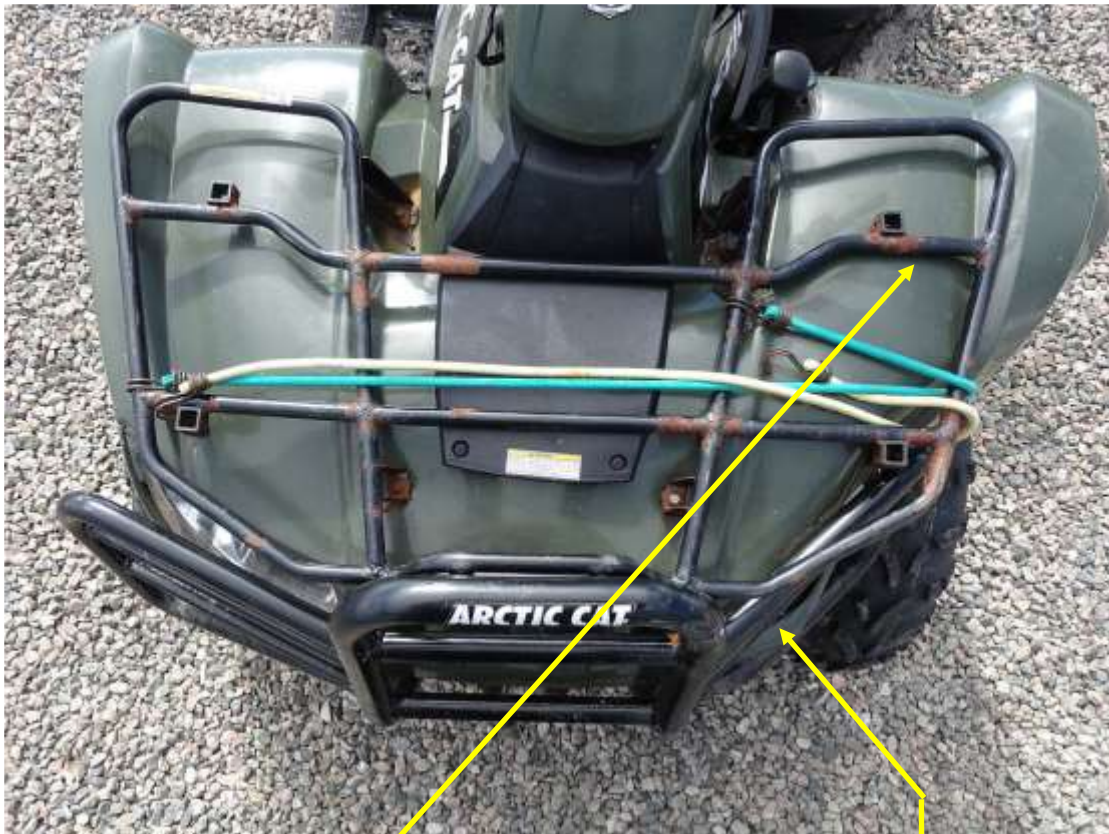
**Photograph 8**

Frame pushed into  
wing panel

Frame pushed  
diagonally across bike

- 33 The damage at the front of the Quadbike shows that it has been struck violently by a force acting at an angle across the bike.
- 34 Diagram 1 shows the kind of collision that would lead to the damage profiles on the two vehicles. In my opinion, the damage profiles are fully consistent with being caused by two vehicles coming into collision.

- 43 Photographs 8 and 9 show evidence of collision damage on Mr Orr's quadbike. There was additional damage to that highlighted but which is not easily seen in the two photographs.

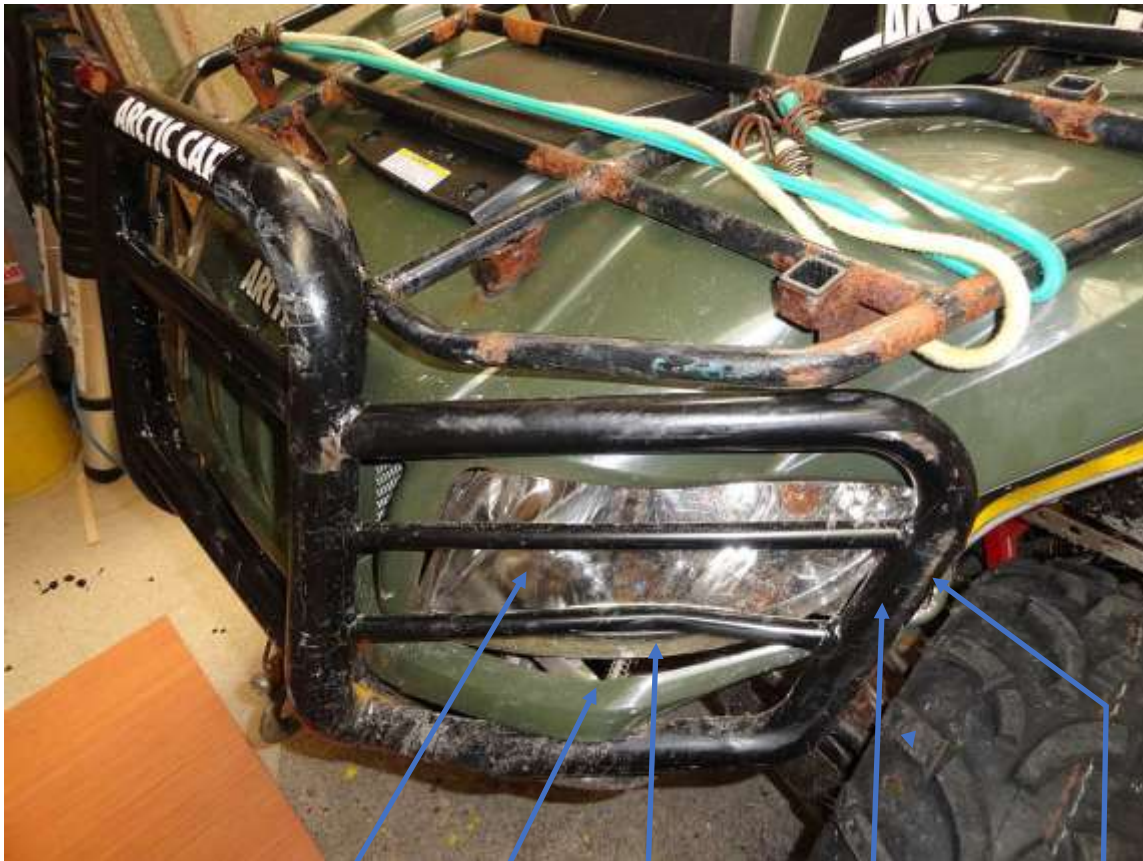
**Photograph 9**

broken headlamp

split wing

bent bar

bars pushed  
into wing

paint  
transfer

- 31 Photograph 9 is a view looking at an angle towards the front nearside of the quadbike. I have highlighted other areas of damage.
- 32 The engineer's report indicates that a new chassis frame would be required together with parts amounting to a cost of £1920. The cost of the time to carry out the repairs is stated to be

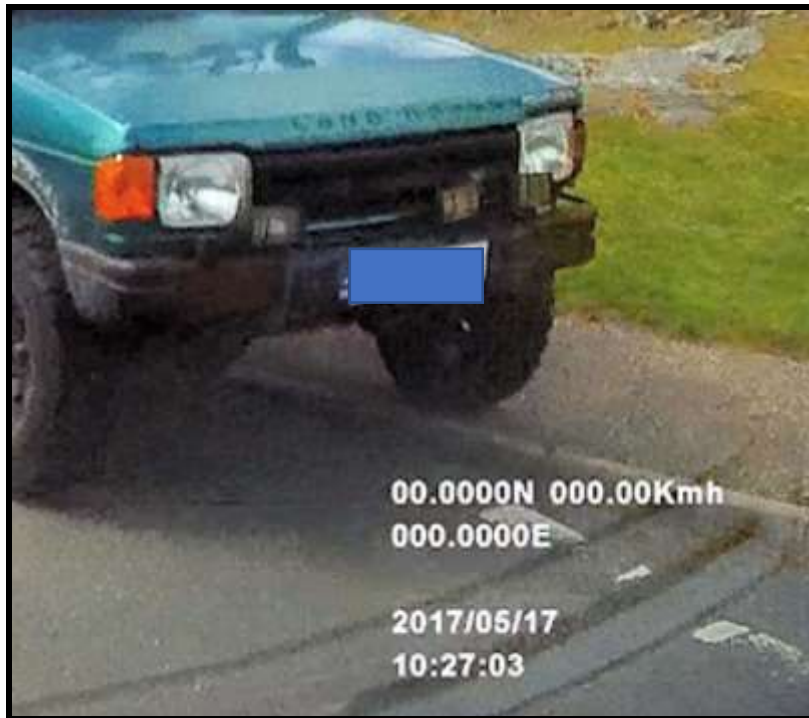
**Photograph 10: Extract from DashCam.**

- 16 Elsewhere, the dunes are too high and steep for any vehicle to leave the beach normally.
- 17 I suggest that Mr Anderson's claim that he could not leave the beach in his four-wheel drive Land Rover Discovery without assistance is invalid.
- 18 After the incident, Mr Orr found a Land Rover Discovery headlight and some plastic embedded in his bike. Photograph 4 shows those found items.
- 19 After the incident Mr Orr says that the Land Rover was not seen for two days. When it next appeared, the headlamp had been replaced but there were still missing items around that nearside head lamp and below that headlamp. Mr Orr has a dashcam recording showing the Land Rover Discovery on the 17th of May 2017 some 11 days post-incident. A frame extracted from that recording is shown at Photograph 10 appended to this report.
